FORD:
2005 Mustang

This article supersedes TSB 05-17-14 to update the Service Procedure.

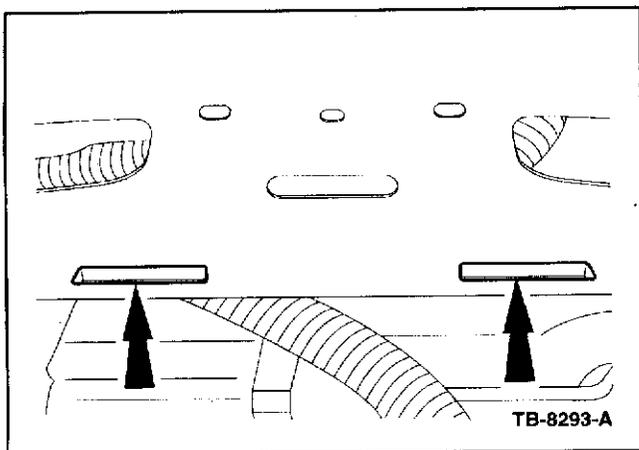
Figure 1 - Article 05-19-10

1. Pull back the seat cushion cover trim and foam to access the (4) flanges in the seat pan (Figure 1).

FIGURES 1 AND 2 ONLY SHOW TWO (2) OF THE SEAT PAN FLANGES, THERE ARE FOUR (4) IN TOTAL.
