**FORD:**

2005-2006 Mustang

# TSB 05-24-6 (Continued)

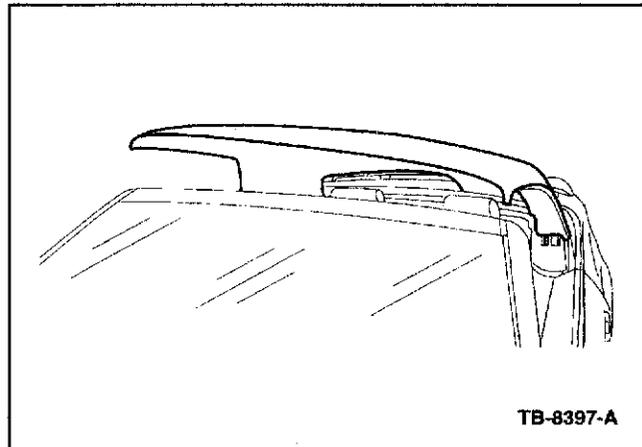
Figure 1 - Article 05-24-6

1. Top lifts unevenly side-to-side with no hydraulic system issues. (Figure 1)

**Replace Side Rails:**

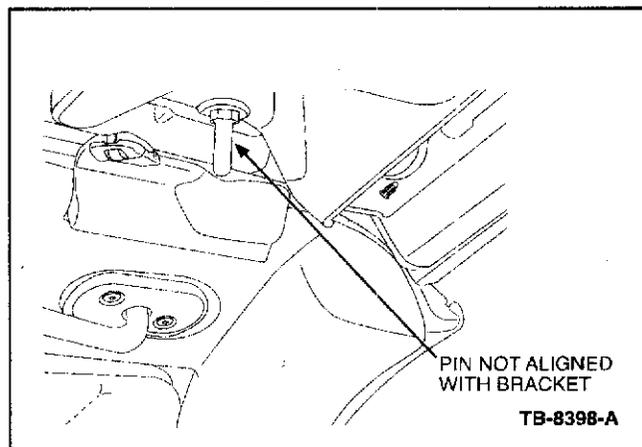
Figure 2 - Article 05-24-6

2. Top latch dowel pins do not align with header latch bracket. (Figure 2)

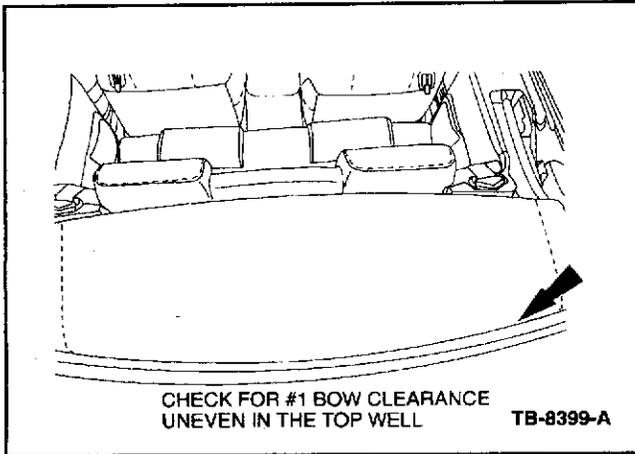
Figure 3 - Article 05-24-6

3. Top #1 bow clearance to top well in the body is uneven. (Figure 3)

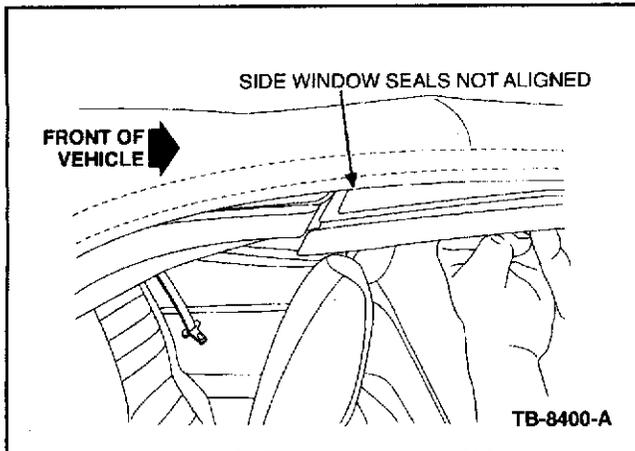
Figure 4 - Article 05-24-6

4. Side window seals do not align properly to side glass. (Figure 4)

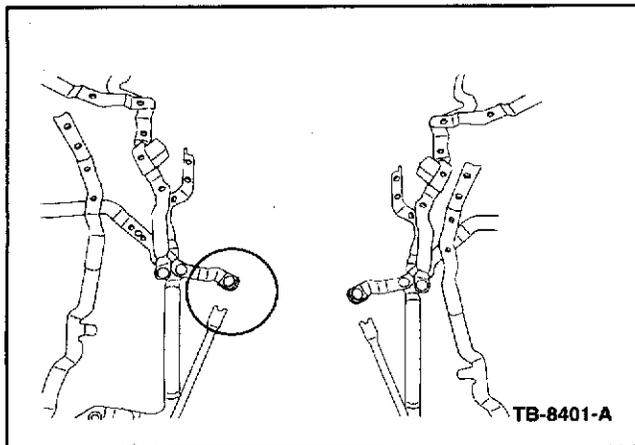
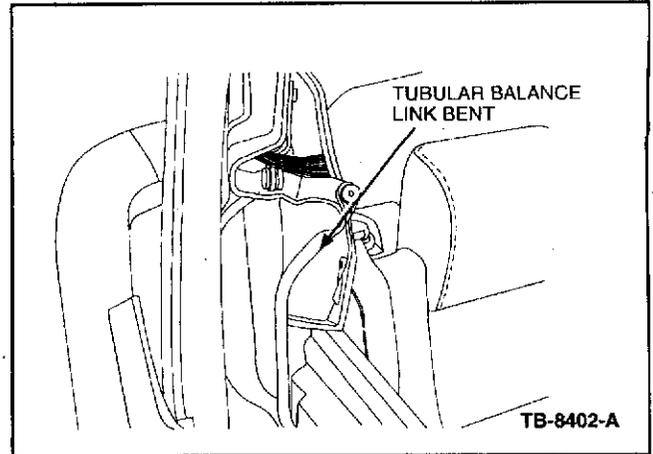
1. Side rail linkage broken. (Figures 5 and 6)

**Replace Top Assembly:**
