# RATTLE/NOISE FROM THE CENTER STACK (RADIO/HEATER) OF THE INSTRUMENT PANEL OR GEARSHIFT AREA

TSB 06-4-1

2005-2006 Mustang

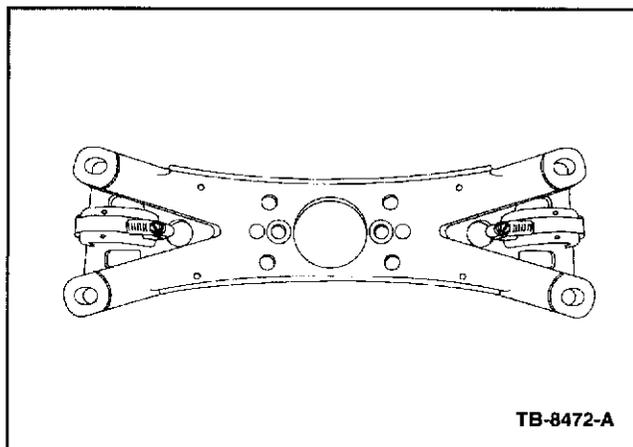
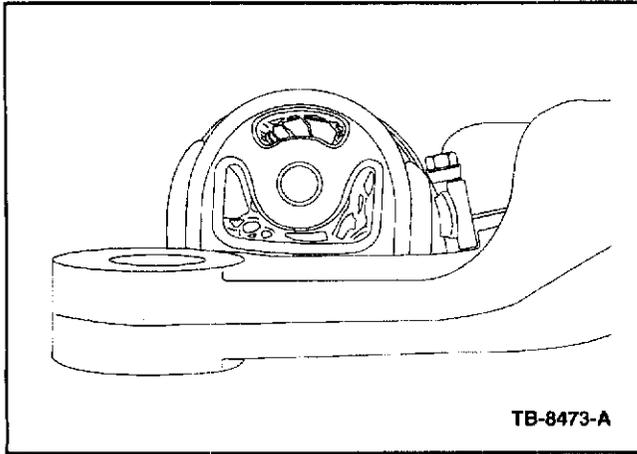
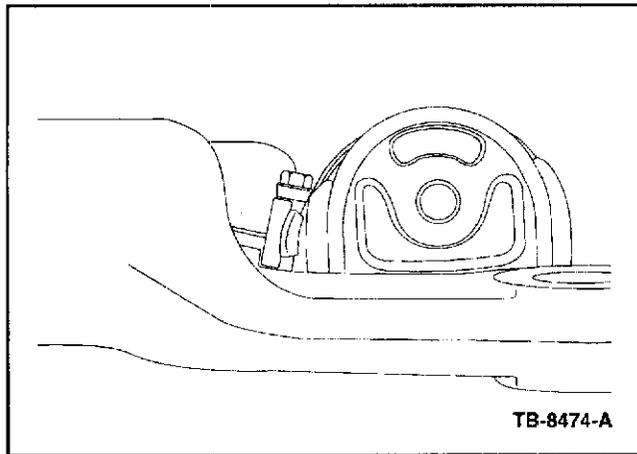
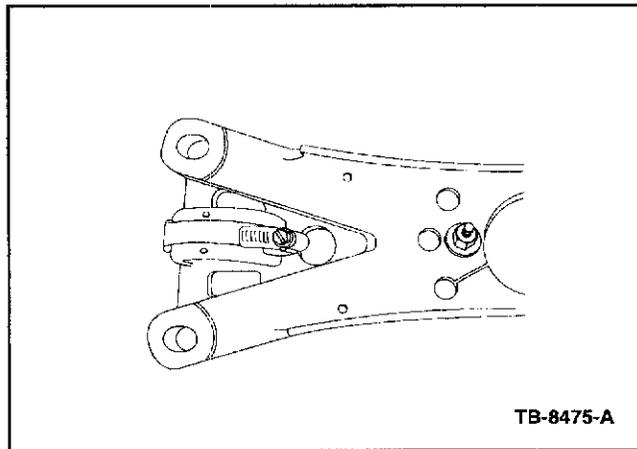
The rattle/noise may be caused by one or both of the exhaust hanger isolators on the trans cross member (number 3 cross member) being loose. To determine if an isolator is loose refer to the Service Procedure.

1. Lightly tap the exhaust hanger isolator located on the transmission crossmember (number 3) with a dead-blow hammer. It should have a solid sound to it.
2. If the hanger has a solid sound to it, do not continue with this TSB and continue with normal diagnostics.
3. If it rattles, secure it with a screw type worm clamp. Use a 3 inch, size 40 stainless worm clamp (obtain locally). Positioned 90 degrees to the exhaust hanger rod. (Figures 1-4). The clamp can be installed without removing the crossmember.

3 INCH, SIZE 40 STAINLESS WORM CLAMPS OR EQUIVALENT SHOULD BE INSTALLED WITH THE SCREW HEAD LOCATED AT EITHER THE 3 OR 9 O'CLOCK POSITION TO MAXIMIZE GROUND CLEARANCE.
