**FORD:**

2005-2008 Mustang

## TSB 07-14-6 (Continued)

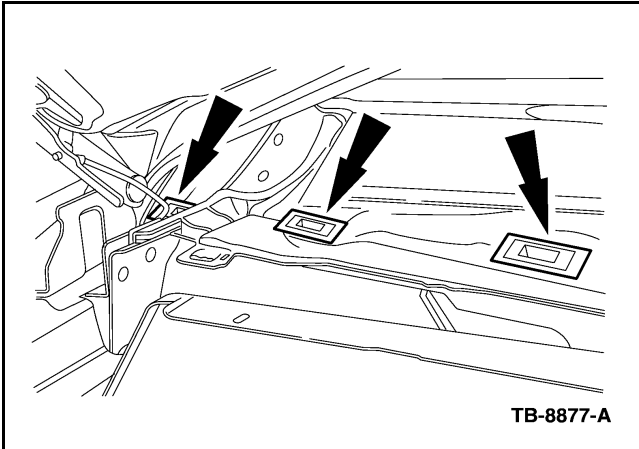
Figure 1 - Article 07-14-6

3. Verify that the ten (10) cowl panel mount grommets and seals are installed and sealing tightly to the vehicle. If any are missing, or the seals are damaged, replace as necessary.
  - a. Apply a small bead of TA-2 Motorcraft® Repair Urethane Adhesive/Seam Sealer around all ten (10) grommets. (Figure 1)

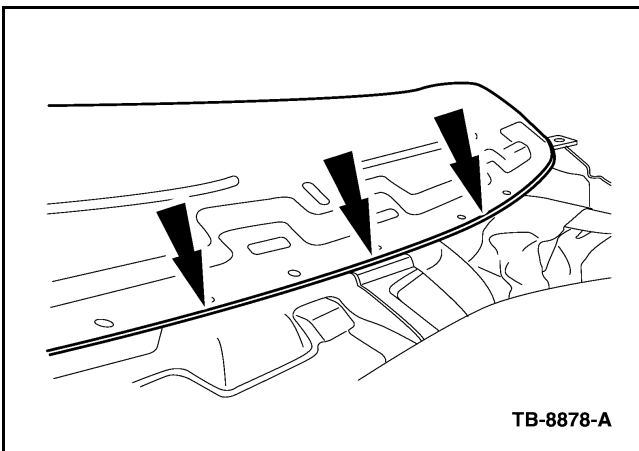
Figure 2 - Article 07-14-6

4. Inspect the cowl panel to bulk head pinch weld and A-pillar to cowl joint for any skips in seam sealer or excessive gaps between panels.
  - a. To ensure a water tight seal, apply a small amount of TA-2 Motorcraft® Repair Urethane Adhesive/Seam Sealer to the pinch weld and work into the seam with fingertip, leaving a small amount on the edge, especially near the windshield center bracket area. (Figure 2)

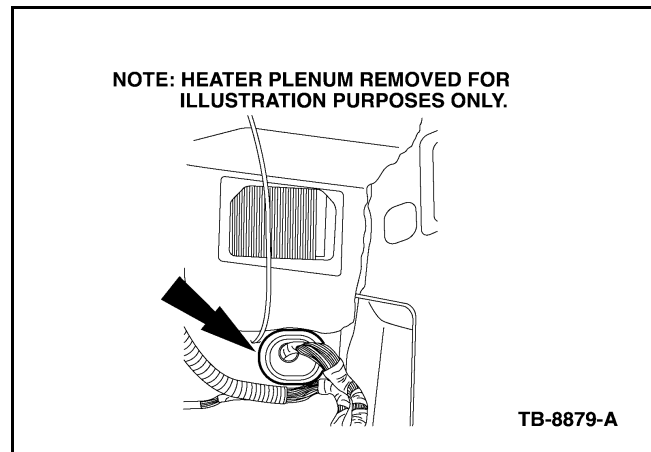
Figure 3 - Article 07-14-6

5. Check the main body wiring harness grommet for proper seating or mis-positioning into the bulkhead on the driver/passenger side.
  - a. Reposition the grommet into the bulkhead making sure the grommet is fully seated and sealed. If there is any aftermarket wiring installed through the grommet, reroute and seal as necessary. (Figure 3)

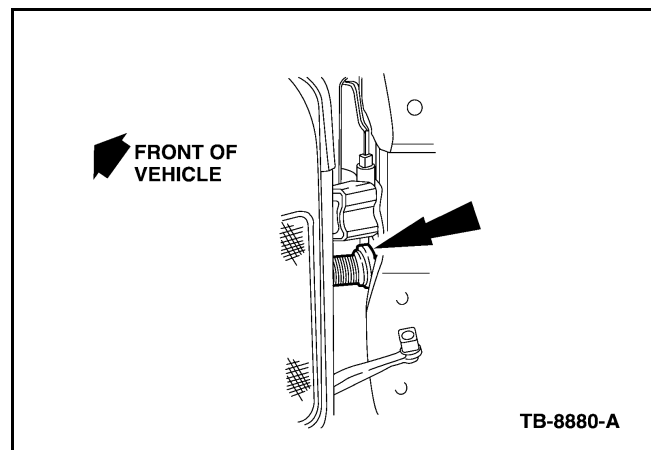
Figure 4 - Article 07-14-6

6. Verify that the door to the A-pillar wiring harness grommet is fully seated into the A-pillar.
  - a. To ensure proper sealing around the wiring harness grommet, apply a small amount of TA-2 Motorcraft® Repair Urethane Adhesive/Seam Sealer and reinstall the grommet into the A-pillar. (Figure 4)

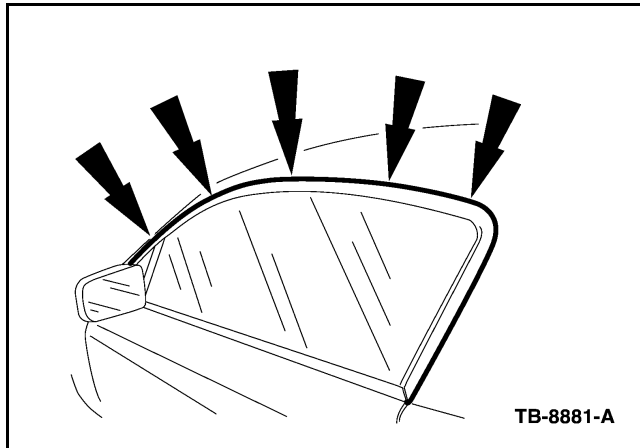
Figure 5 - Article 07-14-6

7. Inspect the foam seal of the window weatherstrip retainer at the A-pillar. Tears in the foam seal may allow water to enter the vehicle between the window weatherstrip retainer and the A-pillar, and travel inside the interior A-pillar trim molding into the dash kick panel area.
  - a. Replace the window weatherstrip retainer, if damaged.
  - b. Reassemble other trim as required. (Figure 5)
