**FORD:**

2005-2009 Mustang

TSB 08-24-10 (Continued)

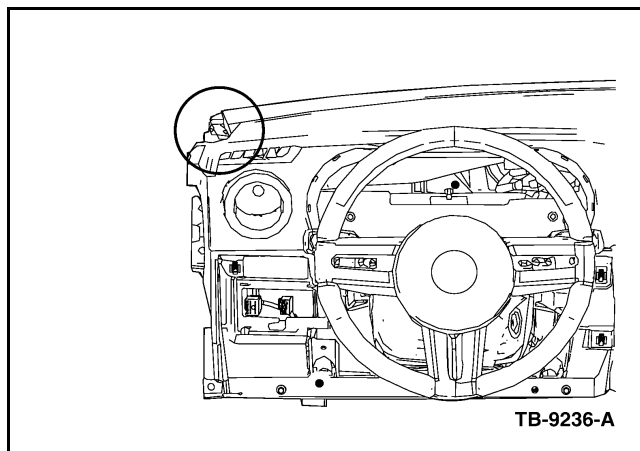
Figure 1 - Article 08-24-10

DASH INSULATOR WAS EXTENDED UNDER THIS AREA FOR 2008 AND 2009 VEHICLES. (FIGURE 1) FOR 2005-2007 VEHICLES MULTIPLE VARIETIES OF TAPE WERE USED UNDER THIS AREA. (FIGURE 2)

1. Remove A-pillar trim.
2. Inspect for tape under flanged edge of dash panel. If tape is missing or damaged, then add or replace with improved tape. This tape has a plastic top coating to protect the felt tape from wear. Install felt tape with adhesive side down. (Figures 1-2)
