**FORD:**

2007-2009 Mustang

This article supersedes TSB **8-16-4** to add a production fix date, update the Issue Statement and Service Procedure.

**ISSUE**

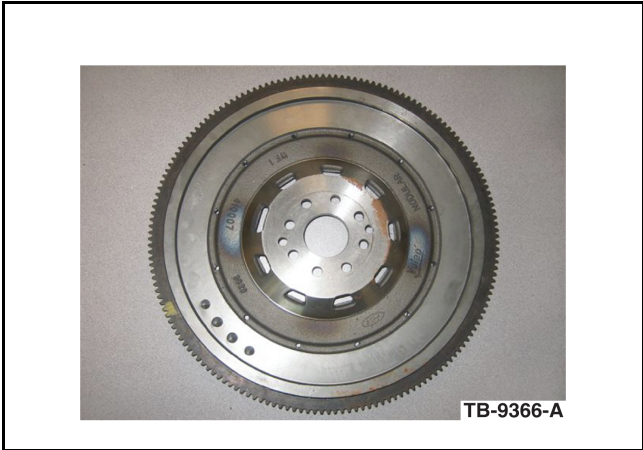
Figure 1 - Article 09-9-2

Located at the end of the procedure are Figures 1, 2 and 3 which show the typical appearance of a flywheel and clutch that has been damaged due to overheating of the clutch. Figures 4, 5 and 6 show the typical appearance of a good flywheel and clutch.

1. Remove, drain, disassemble and clean the transmission per Workshop Manual (WSM), Section 308-03C.
2. Remove and replace input shaft and all synchronizer assemblies per WSM, Section 308-03C.
3. Assemble the transmission per WSM, Section 308-03C.
4. Remove clutch disc and plate assembly and pilot bearing per WSM, Section 308-01.
5. Remove and replace flywheel per WSM, Section 303-01C. Discard old bolts and use bolts provided in flywheel kit.
6. Install new pilot bearing per WSM, Section 308-01.
7. Install new clutch disc and plate assembly per online WSM, Section 308-01 (vehicles with solid design flywheel). Discard old bolts and use bolts provided in clutch kit. Tighten bolts to 89 lb-in (10 N•m) in a star pattern. Tighten an additional 90 degrees in a star pattern.
